Work Order# 18919 Damage# 42539

SITE INSPECTION REPORT
FACILITY DESCRIPTION

CATEGORY G
Beaches

Physical Location/Address: LEAGUE CITY BOAT RAMP & PARK
FM 270, LEAGUE CITY TX

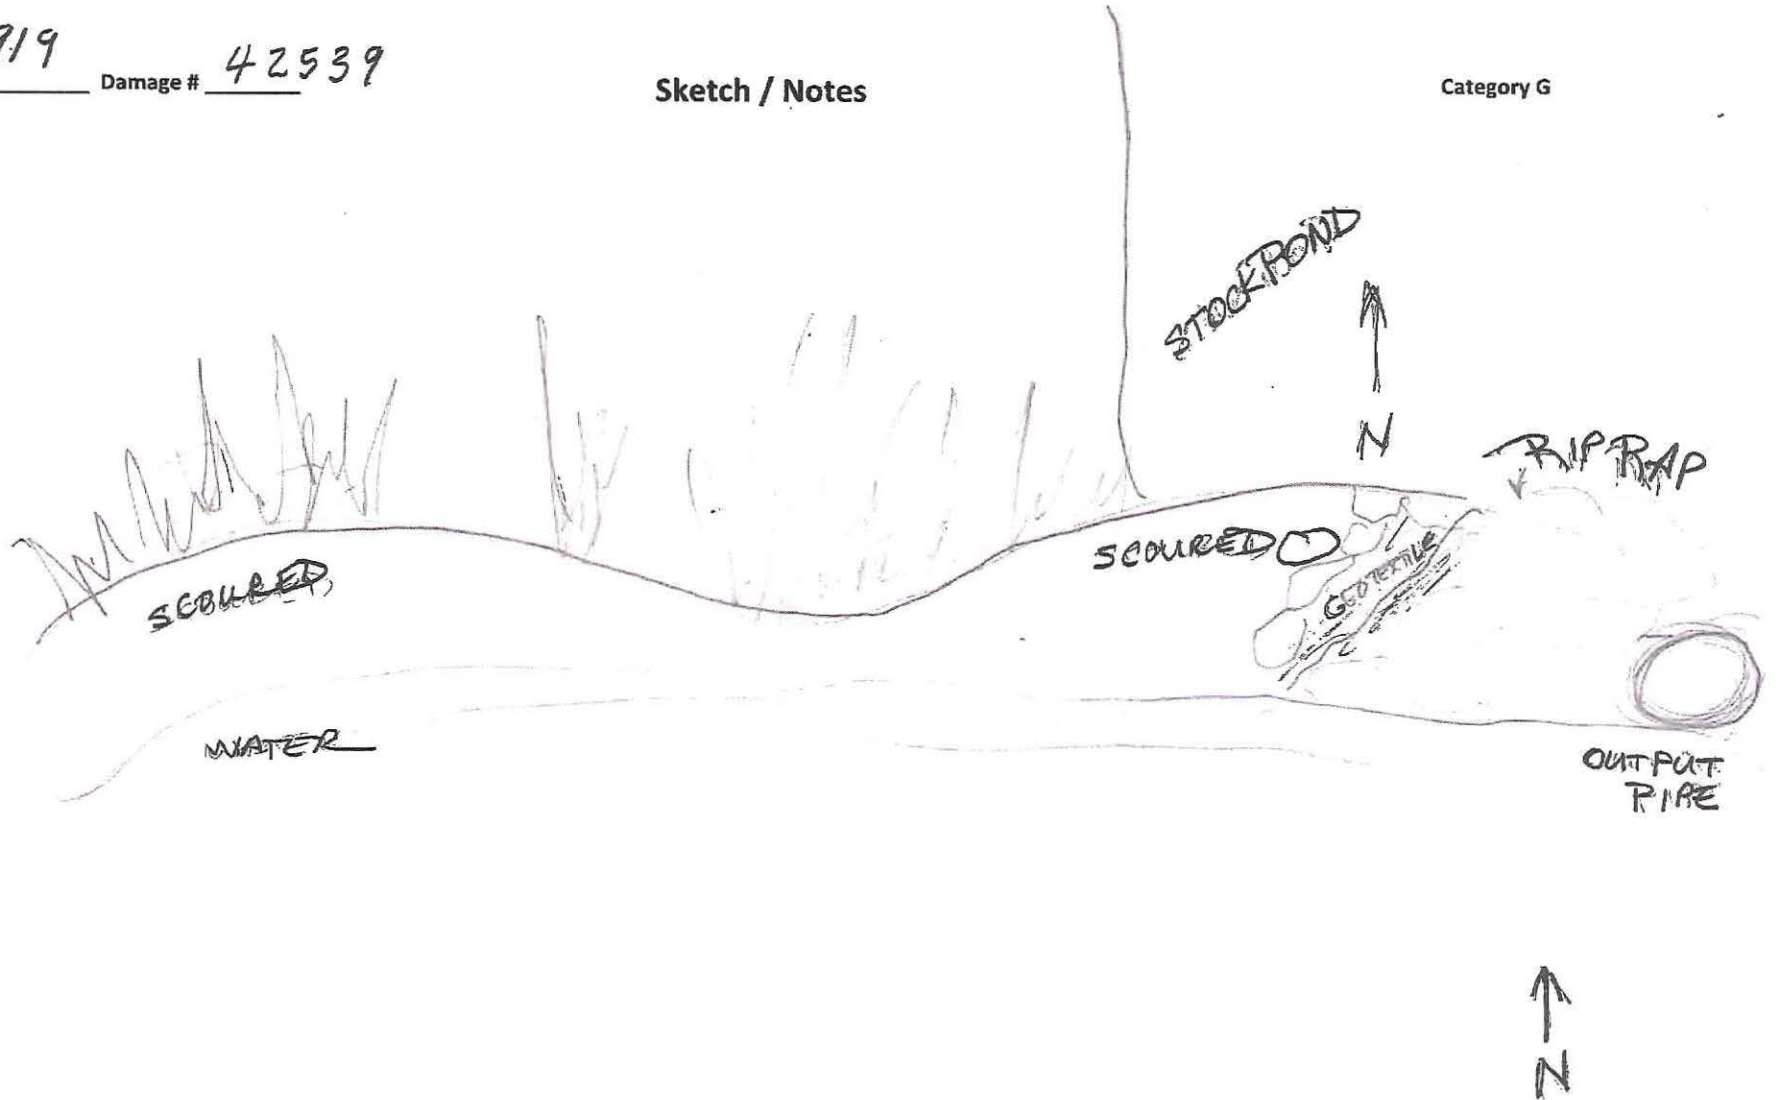
Sketch / Notes

| <p>Wetland Preservation Site Man made lake Outlet pipe - Ike took out - replaced Has consents to approach w/ TXDOT to operate on boat ramp 6in above high tide - water back flows & fish enter. Applicant did bottom survey of entire lake BANK BESIDE PIPES SCOURED GEOTEXTILES RIP RAP WANTS TO WORK W/ FISH & WILD LIFE WETLAND PRESERVATION</p> | <p>GPS 29.534516, -95.096181 BOAT RAMP</p> <p>SHELL MIDDEN DRAINAGE OUTFLOW THROUGH MIDDLE INDIANS KARANKAWA GO BEHIND VEGETATION AND PLACE ROCK</p> |
