## SANDER ENGINEERING CORPORATION

March 13, 2025

Re: Butler Road Lift Station Emergency Bypass and Repairs

22-052

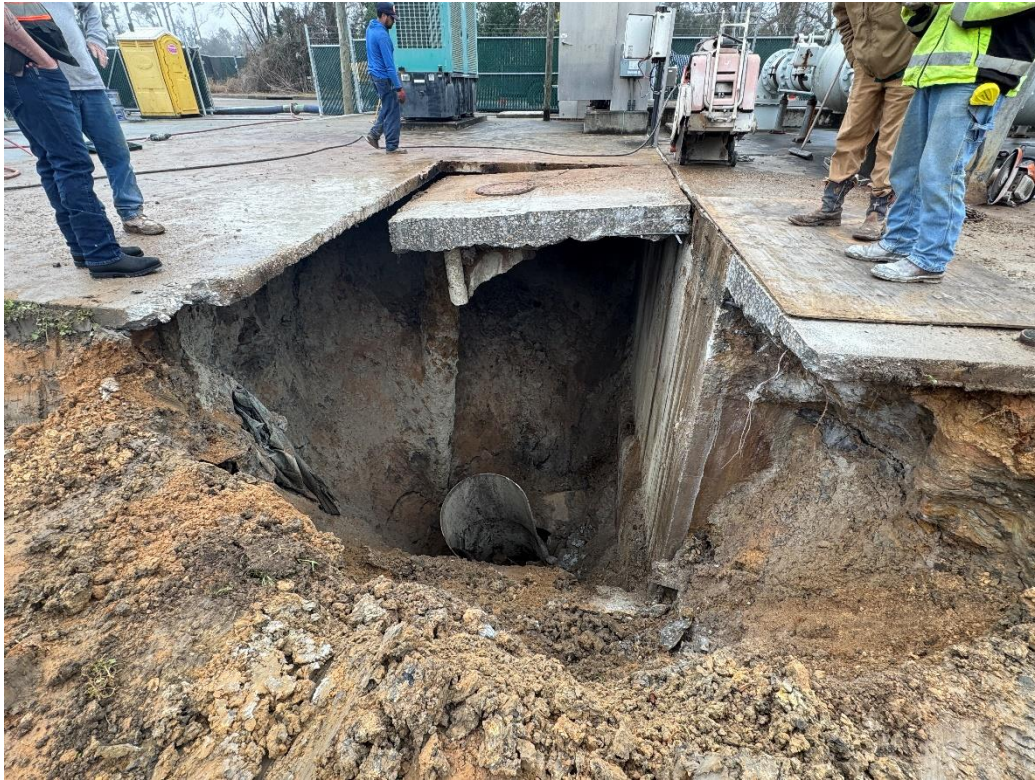
Failure of manhole and 42" gravity sewer into lift station

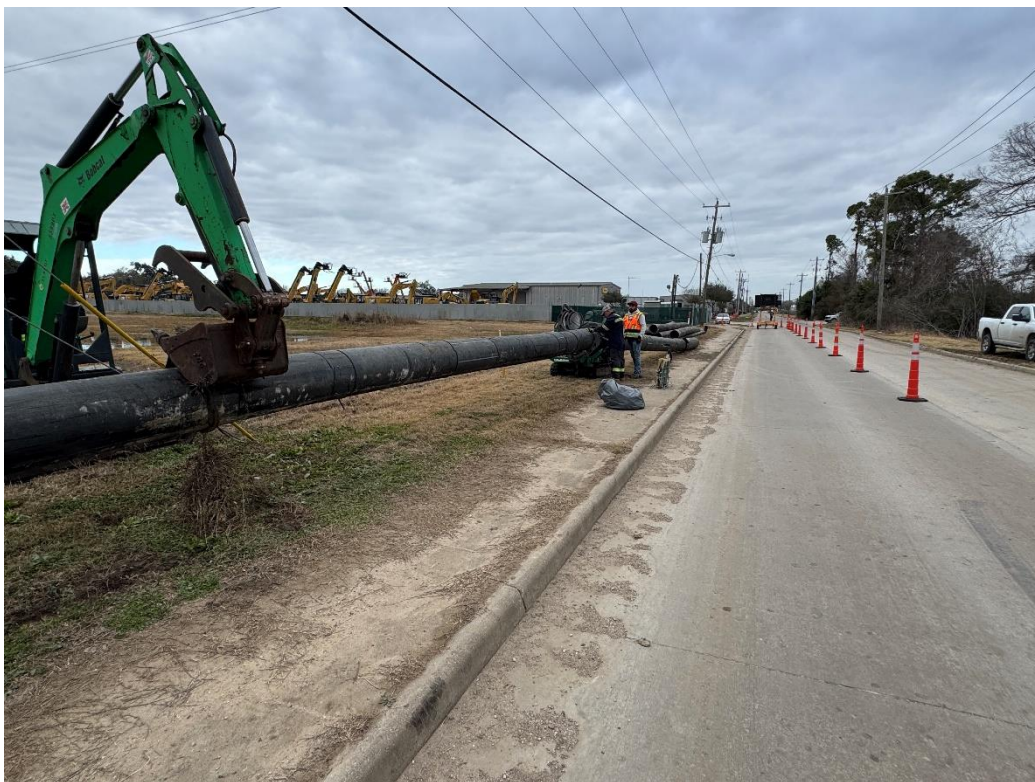
Bypass piping setup

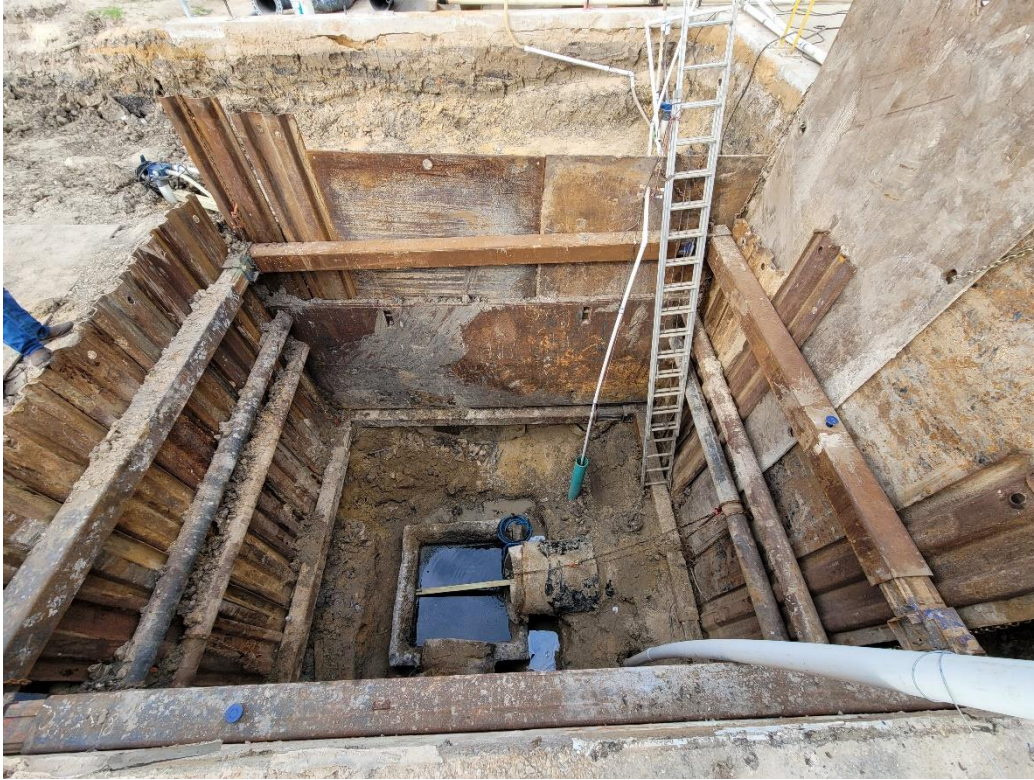
Initial excavation and shoring

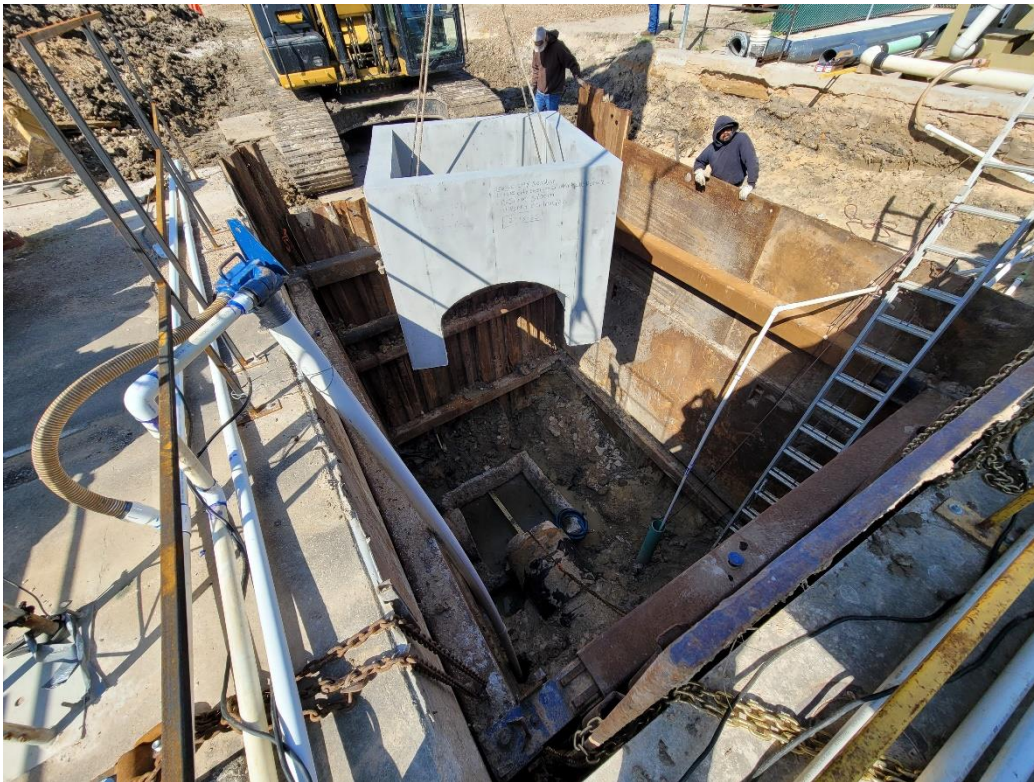
Installation of manhole base

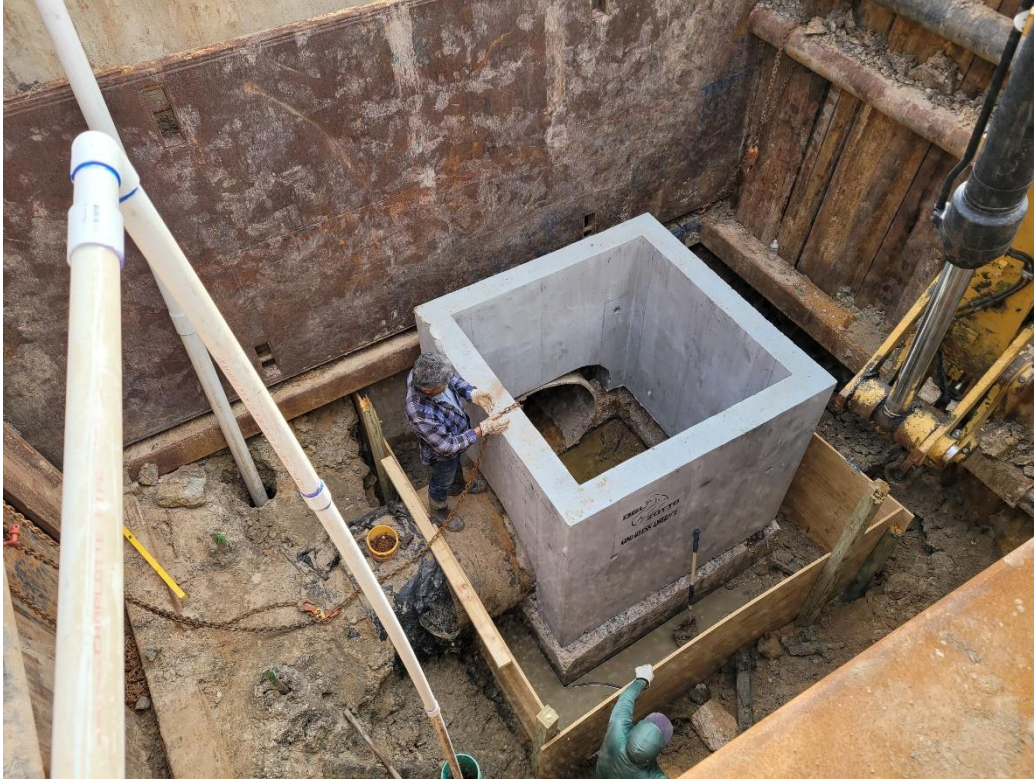
Manhole base installed

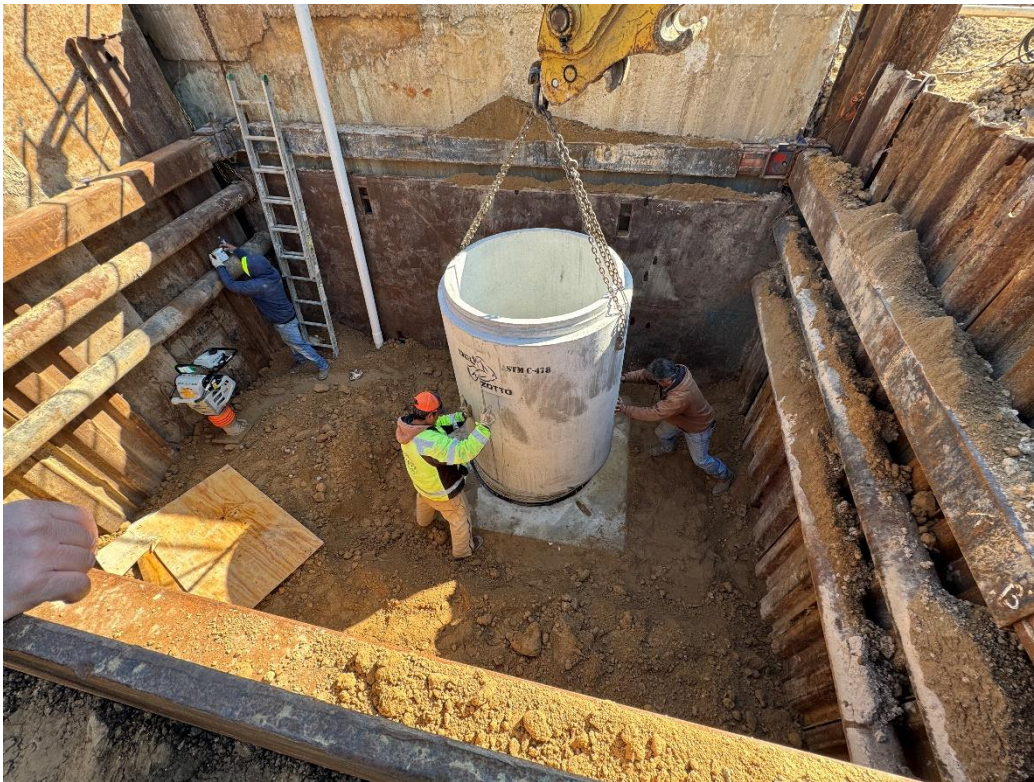
Installation of manhole cone

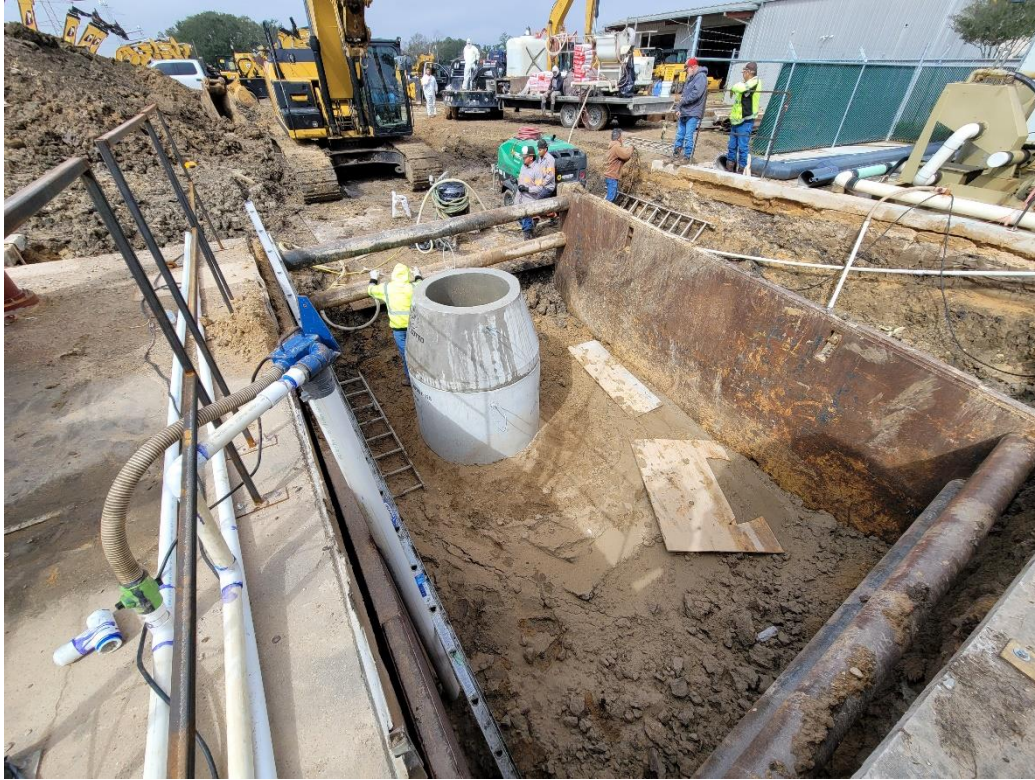
Backfill of manhole an installation of manhole cone

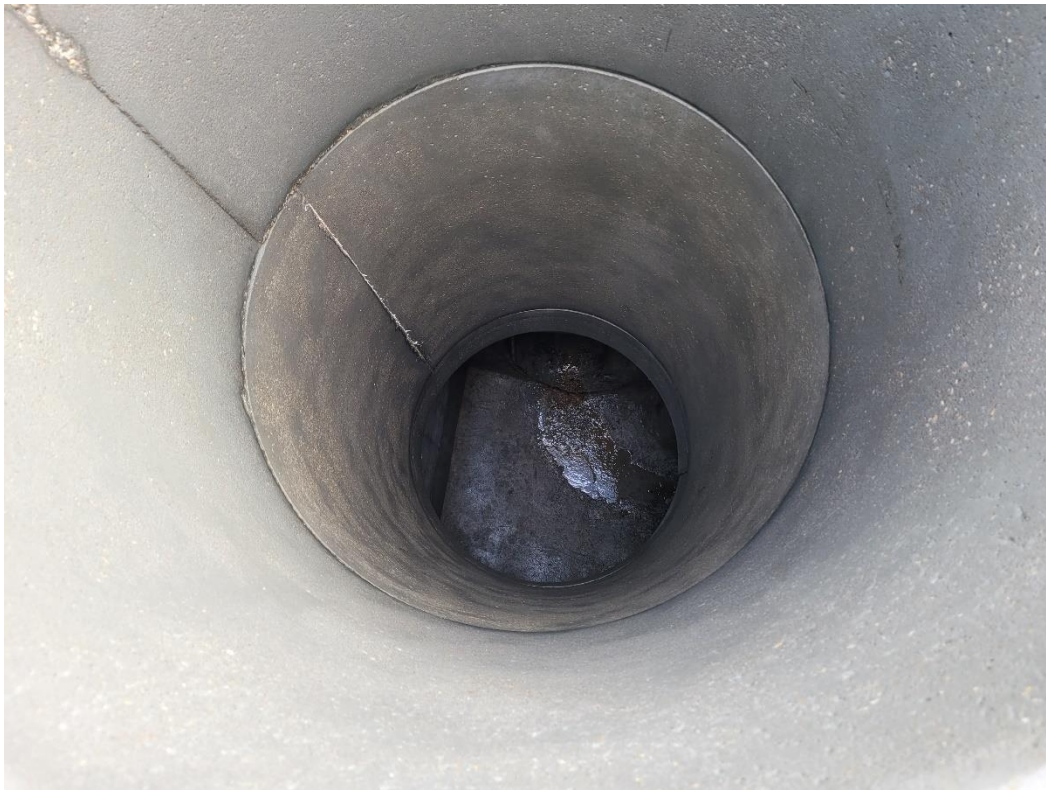
Installation of SewperCoat Lining

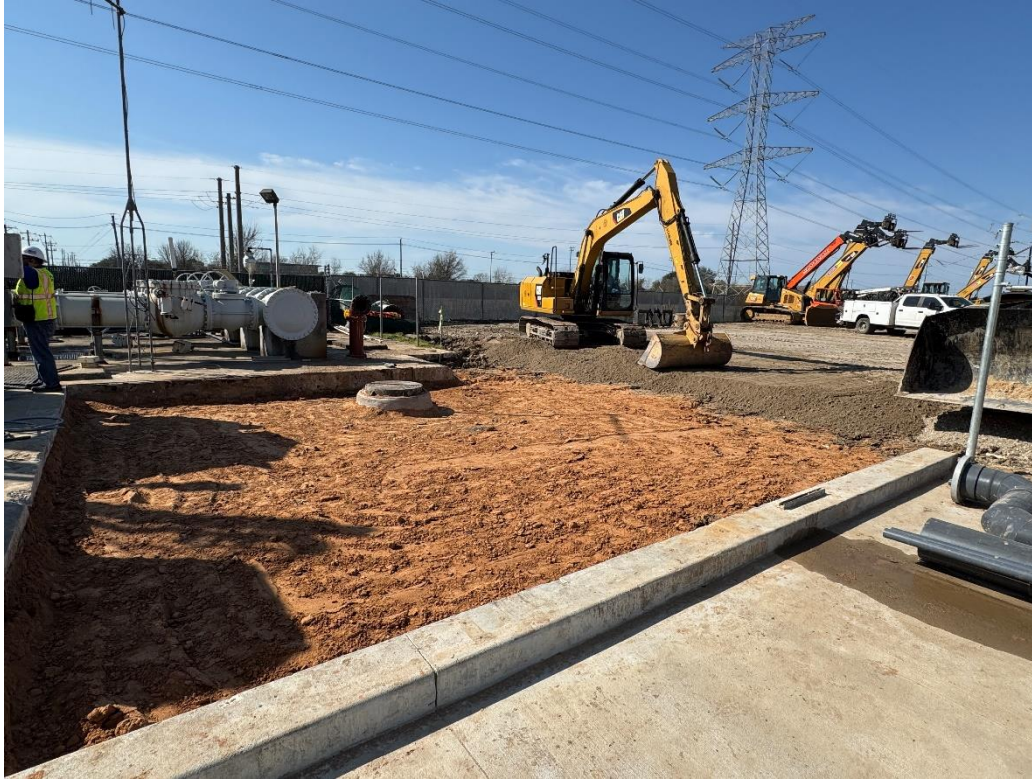
Manhole installation and backfill complete
