## Slope Paving Report

Bay Area Boulevard at Alderwood

## Slope Paving Failure at Sound Wall

June 26, 2014

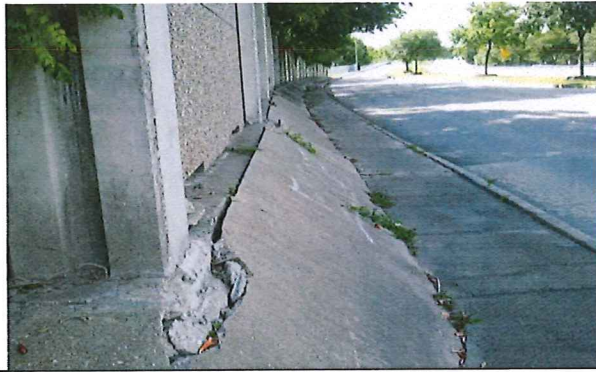
Slope Paving Between the Sidewalk and the Sound Wall

The sound wall was designed with 5' long X 4" deep drainage openings to facilitate sheet flow from the backyards of houses east of the sound wall onto Bay Area Blvd where the water is collected by roadway inlets. In recent years the slope paving has developed severe cracking and failure along the entire length of sound wall. Visual observation indicates that the sheet flow

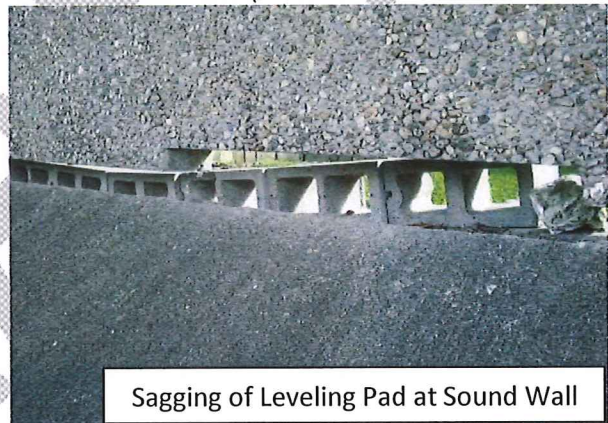
Sagging of Leveling Pad at Sound Wall

from the backyards is not draining as originally intended. It appears that ponding behind the wall has created settlement of the natural ground and sheet flow is no longer able to drain through the drainage slots as intended. This created a situation where the leveling pad and slope paving settled and cracked and residents have resorted to make-shift measures to close up the enlarged openings. These measures include wire fabric, plywood panels, and concrete blocks which exacerbates the problem by trapping trash and debris behind the wall and a creates a dam effect at the openings.

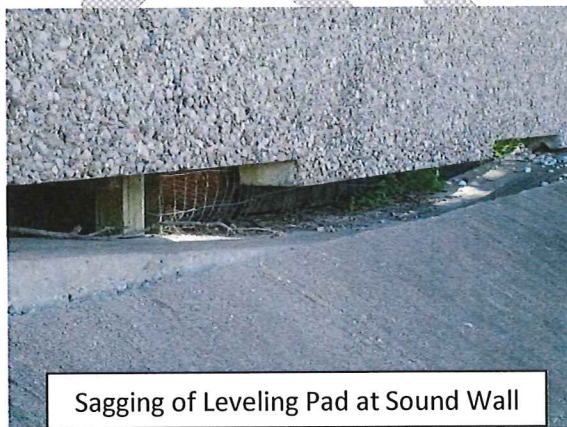
Sagging of Leveling Pad at Sound Wall

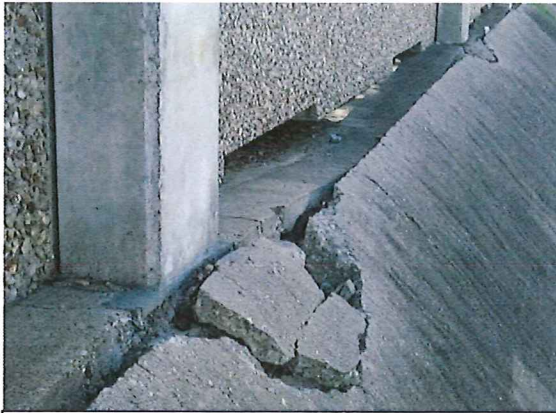
Slope paving pulling away from drilled shaft and sagging of sound wall leveling pad.

The primary factor for the existing natural ground settlement and the standing water at the base of the sound wall appears to be caused by improper drainage. In addition, the slope paving does not have an underdrain system to facilitate the drainage of water trapped behind the slope paving. Review of the TxDOT plans for the sound wall indicates that the elevation of the leveling pad was originally intended to be at the elevation of the roadway top of curb. Field conditions in this segment of Bay Area Boulevard made it necessary to install the leveling pad at a higher

elevation thus requiring the slope paving between the sound wall and the sidewalk. The slope paving was installed but it appears that the necessary backfill embankment (reinforced volume or cement stabilized sand), and weep holes and underdrain was not installed behind the slope paving.

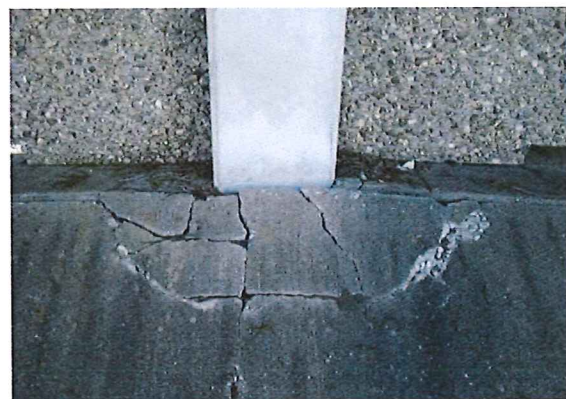
The second factor to address is the slope paving failure and leveling pad settlement. The slope paving has pulled away from the drilled shaft at every column due to settlement. Options that would allow the repair of the areas of concrete failure are explored below.

Slope paving around column cracked due to settlement. No expansion joint to separate drilled shaft foundation from

Saw cut and remove the slope paving a minimum of two feet around each of the drilled shafts with a full depth saw cut, install flowable fill or properly compacted select fill, where voids are found, and install a board expansion joint to separate the new and old slope paving. Where the damaged area extends beyond two feet, the saw cut should extend to the limit of the damaged area. Remove the concrete immediately around the column and install new concrete, or similar surface material. The expansion joint will allow the concrete around the column to move separately from the other slope paving and should minimize future cracking. In addition to the areas around the columns, saw-cut and replace the slope paving where failure has occurred in other select areas. The sound wall leveling pad may be able to be raised by

jacking methods to the correct elevation, however a geotechnical investigation should be done to confirm this method before it is implemented. See Exhibit B-1 for a detail of this option. The engineer's opinion of construction cost for this work is in the amount of \$96,000. See Appendix A for a more detailed cost estimate for this option.
