## **Compressor fact finding REPORT**

**League City**

**Odin COMPRESSOR SC50 #8749**

**Purpose:** Fact finding for compressor #8749

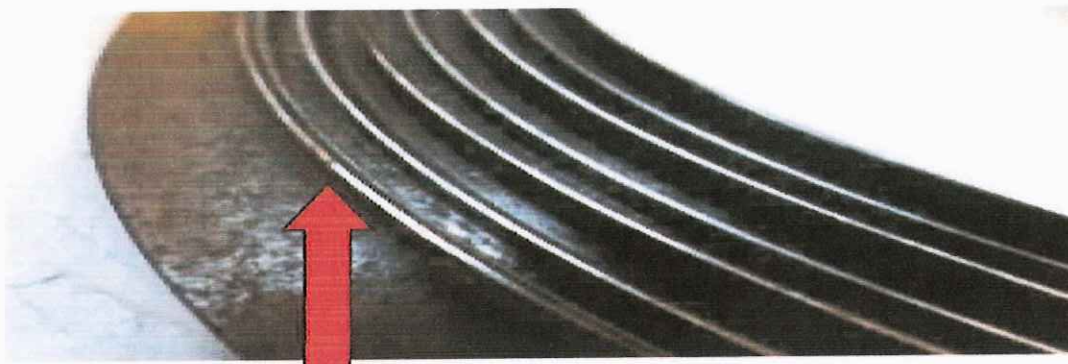
Photo no. 1: Labyrinth ring H303 with damaged cams.

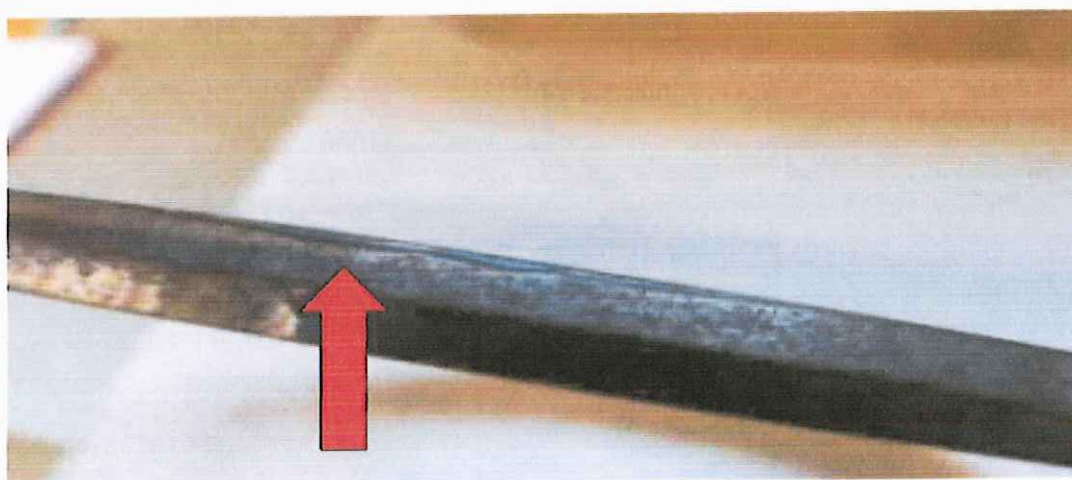
Photo no. 2: Labyrinth ring H303 with signs of over heating

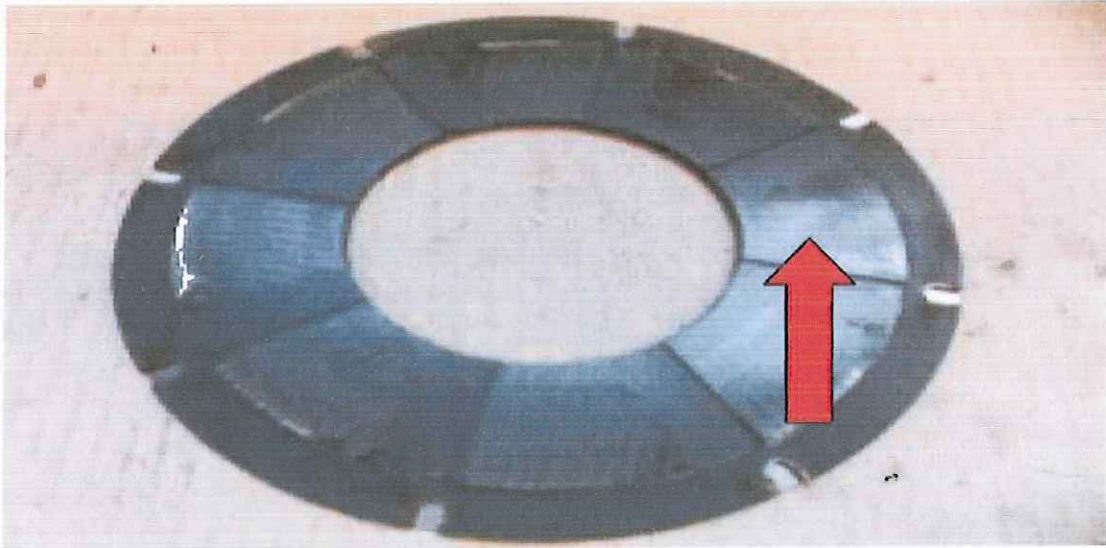
Photo no. 3: Thrust bearing X115 with clear wear marks on air foils.

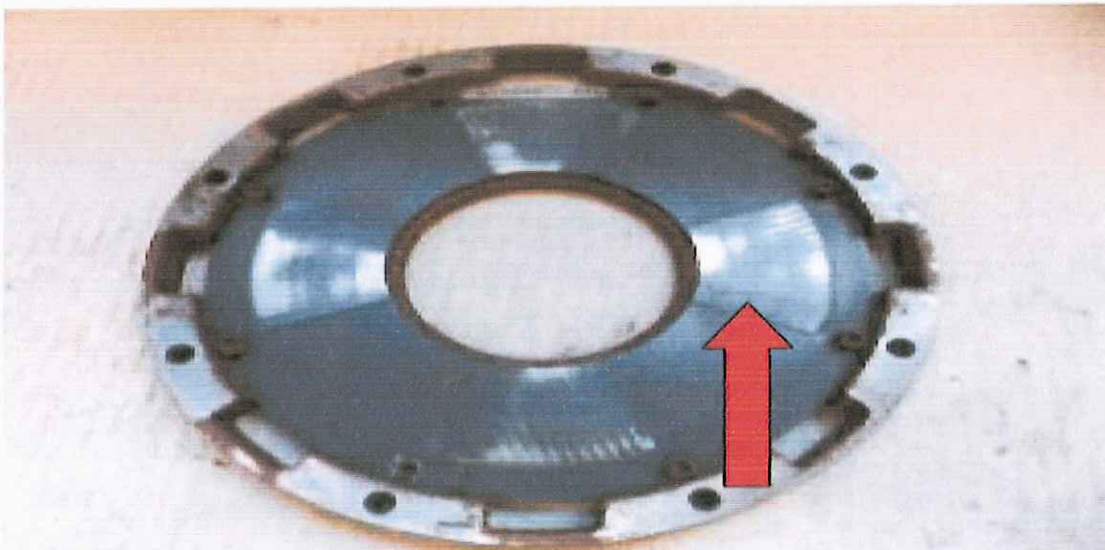
Photo no. 4: Counter bearing X116 with clear wear marks on air foils.

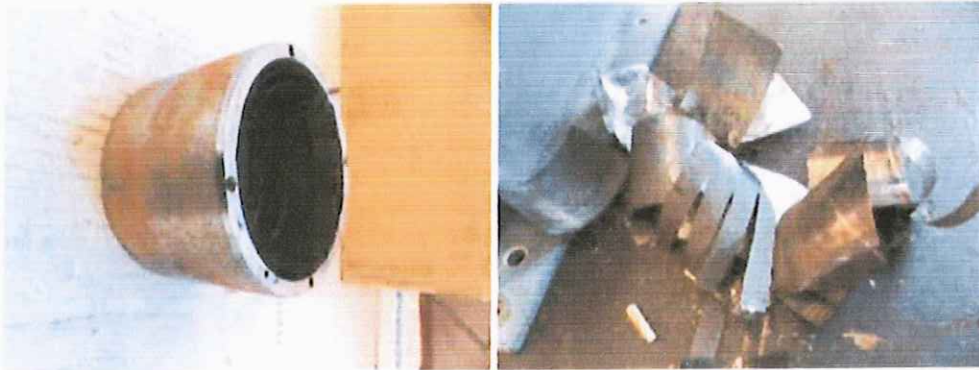
Photo 5 + 6: Bearing complete Ø100, X124 is damaged and shall be replaced. Quoted on 457360

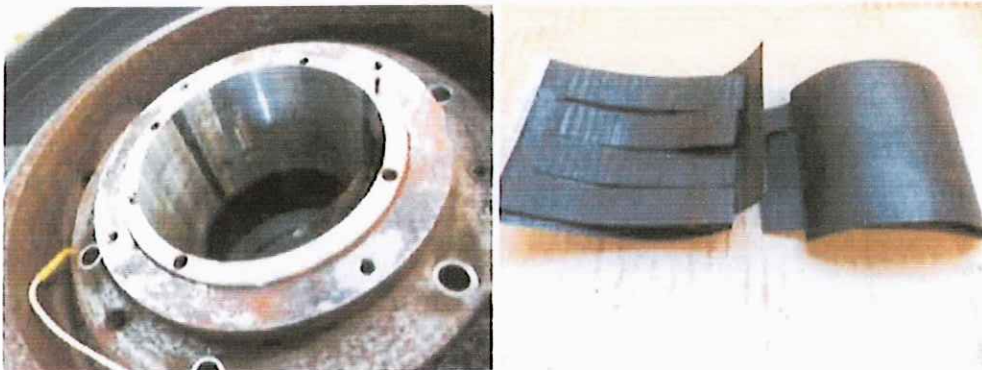
Photo 7 + 8: Bearing complete Ø100 , X143 is damaged and shall be replaced. Quoted on 457360

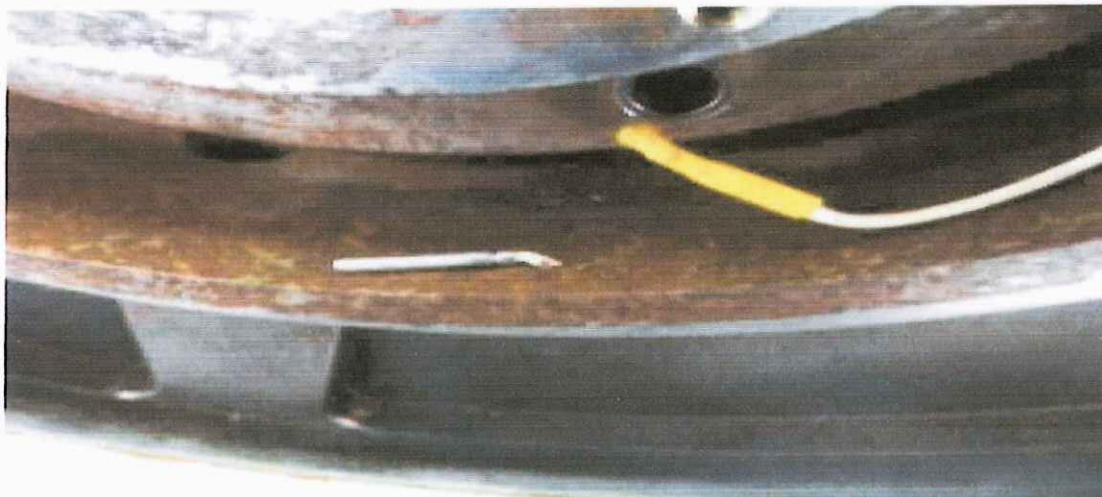
Photo 9: PT – 100 sensors X153 and X154 is damaged.

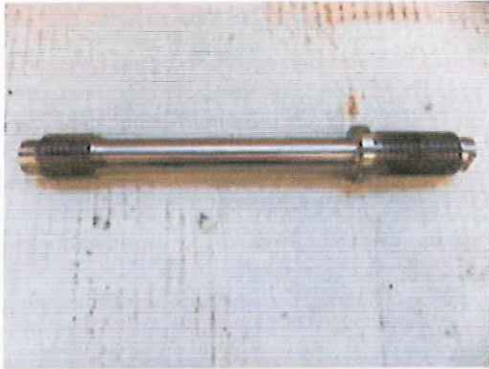
Photo 11: The central screw is visually in OK condition

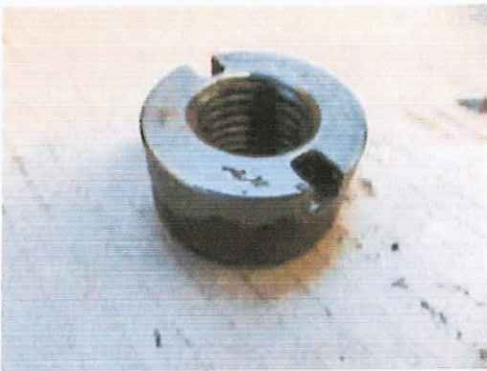
Photo no. 12: Rotor nut R407 is visually in OK condition

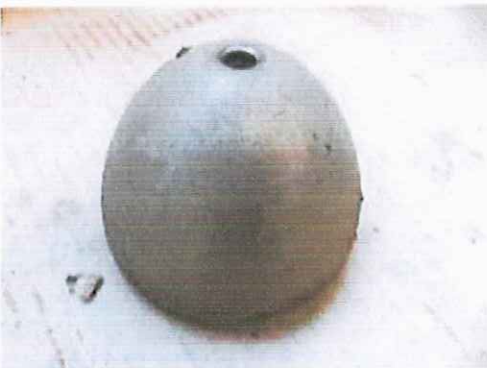
Photo no. 13: Spinner R412 appears to be in ok condition

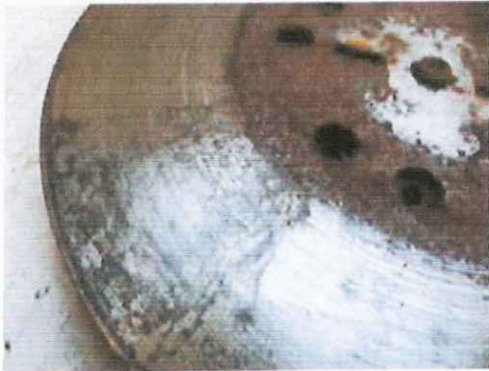
Photo no. 14: Thrust collars R413 is corroded.

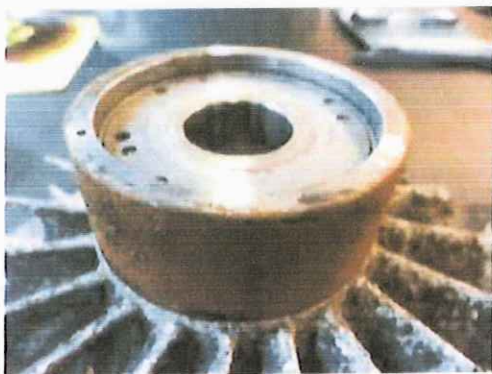
Photo no. 15: The stop ring R408 shows sign of corrosion

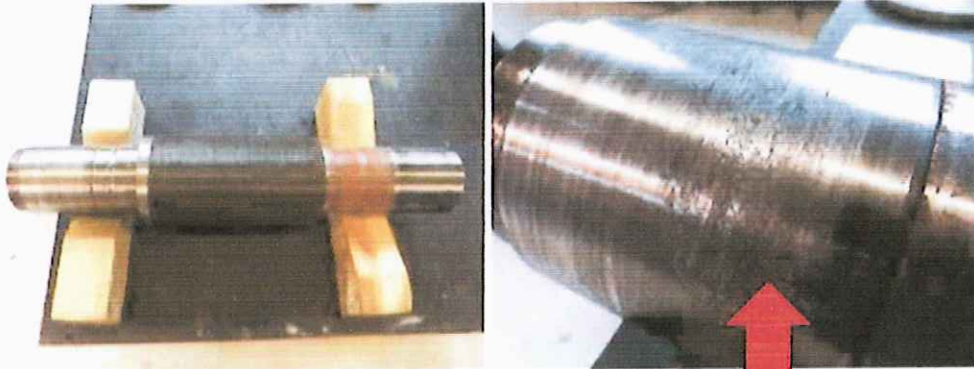
Photo no. 16 + 17: The rotor shaft with bushings R420 is corroded and damaged

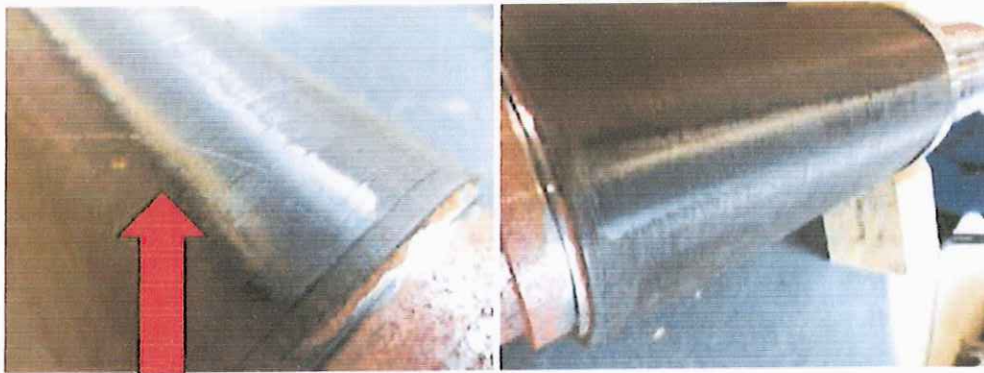
Photo no. 18 + 19: The rotor magnet DBL120908B R427 is damaged.

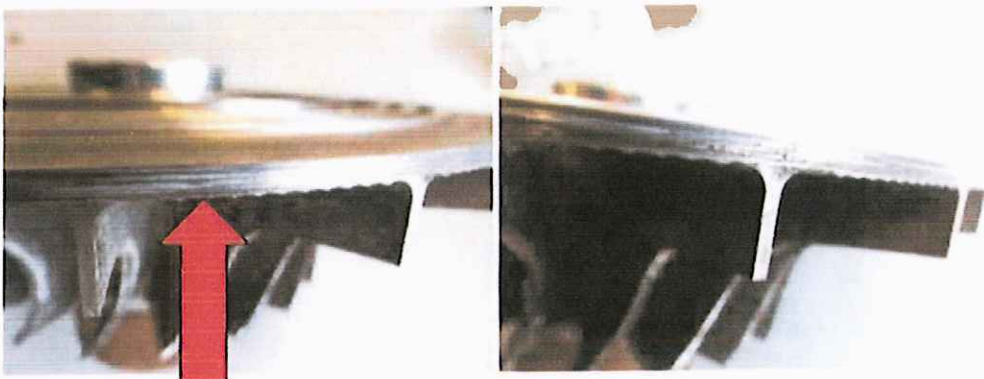
Photo 20 + 21: Impeller R414 with wear marks from contour ring.
