RE: EVALUATION OF CITY OF LEAGUE CITY
WELDED GROUND STORAGE TANK NO. 1
AT THE CALDER WATER PLANT

**EVALUATION OF
CITY OF LEAGUE CITY
WELDED GROUND STORAGE TANK NO. 1
AT THE
CALEDON WATER PLANT**

REPORT OF: Welded Ground Storage Tank No. 1

DATE INSPECTION PERFORMED: March 27, 2017

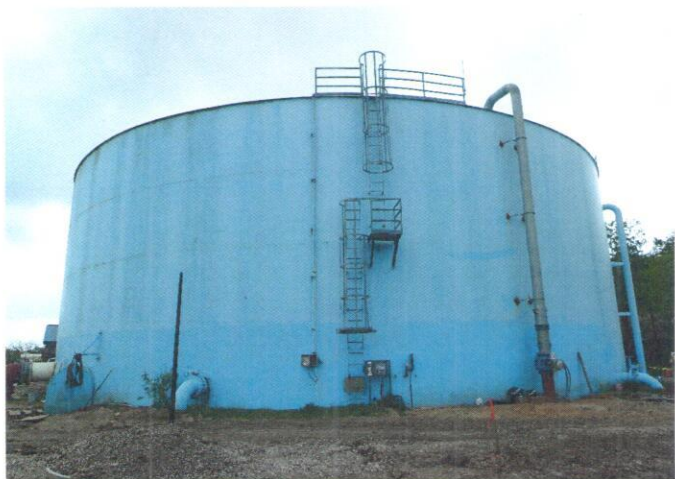
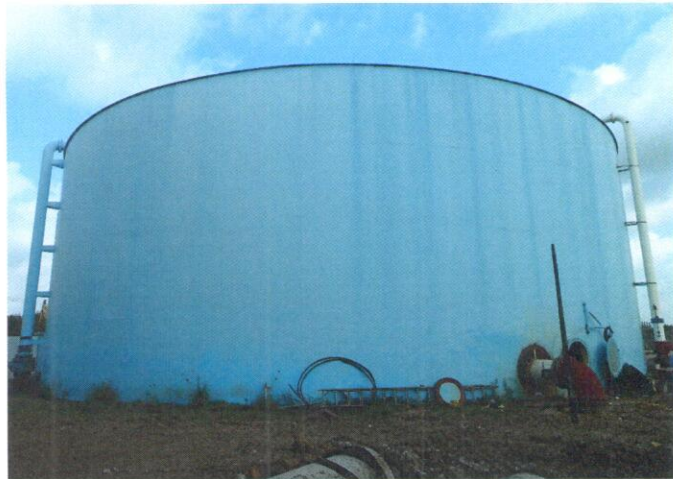
The exterior protective coating system is in the initial to advanced stages of deterioration. Photo 1 and 2 provides overall views of the exterior coating system. The protective coating has chalked, faded and is no longer self-cleaning. Impact areas on the tank exterior are shown in photo 3 with surface rust. Overall views of the roof are shown in photos 4 and 5 with coating failures noted throughout. Close-up views of the coating failures and surface rust are shown in photos 6 through 9. Photo 6 also shows deterioration of the non-skid surface on the roof of the tank. Photo 9 shows an area of previously ponding water on the roof. This condition will lead to premature failure of the protective costing system. The surface water piping and connections are shown in photos

The exterior protective coating system is in the initial to advanced stages of deterioration. The protective coating has chalked, faded and is no longer self-cleaning. Numerous coating failures were noted on the roof of the tank. The interior protective coating system is in the initial to advanced stages of deterioration. The floor of the tank has failed in the form of blisters. It is recommended to replace the exterior and interior protective coating systems as soon as possible to prevent any further deterioration. During rehabilitation, the interior ladder and overflow box will need to be replaced. It would also be recommended that the City continue an annual preventative maintenance program to help prevent any major repairs in the future.

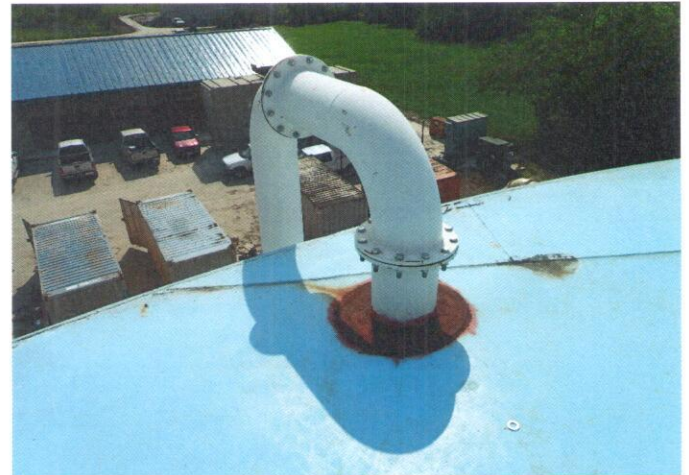
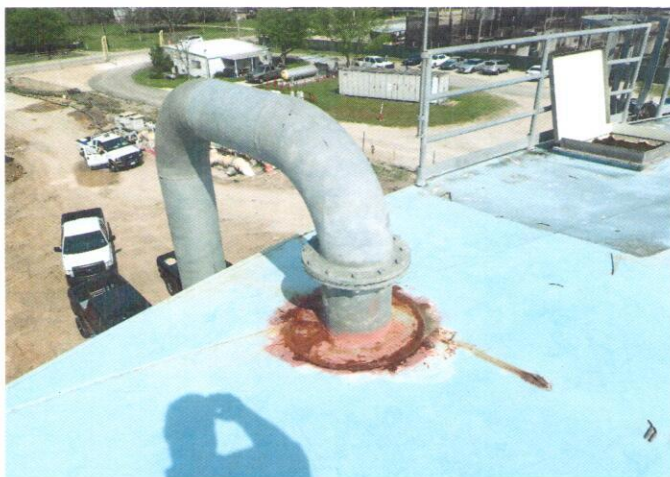
10 and 11 with surface rust at the roof connection area. A maintenance hatch is shown in photo 12 with coating failures and surface rust. The roof vent is shown in photo 13 with surface rust along the leading edges of the collars. The screens continue to provide adequate protection against insects, rodents, vermin and other intrusions into the tank. The roof overflow and access hatches are shown in photos 14 and 15 with coating failures along the interior leading edges. The sidewall access manway and cleanout are shown in photos 16 and 17 in acceptable condition. The overflow flap and drain valve appear to be operating properly, as shown in photo 18.

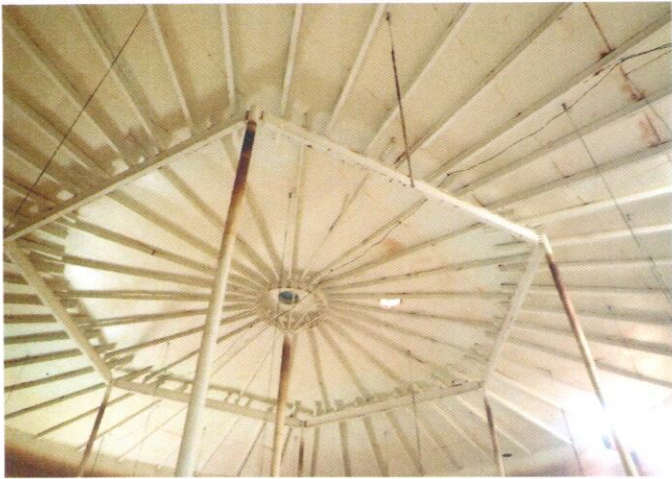
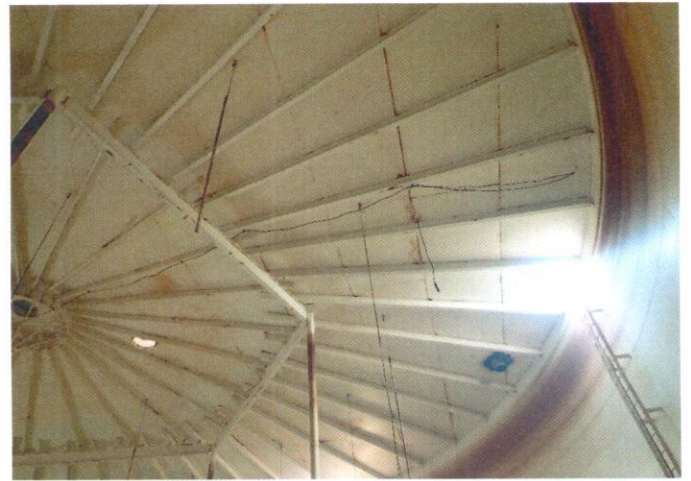
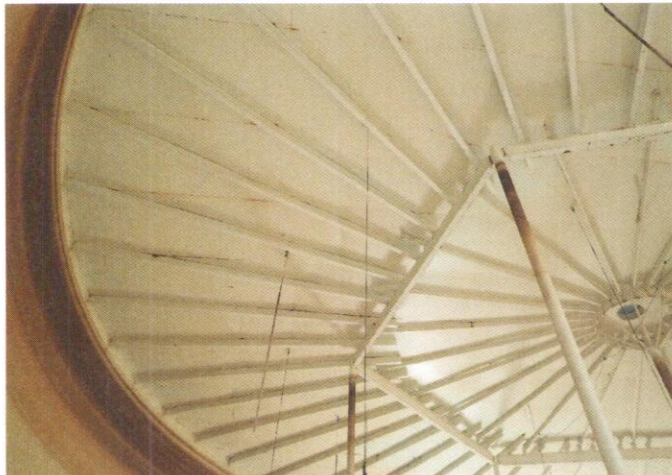
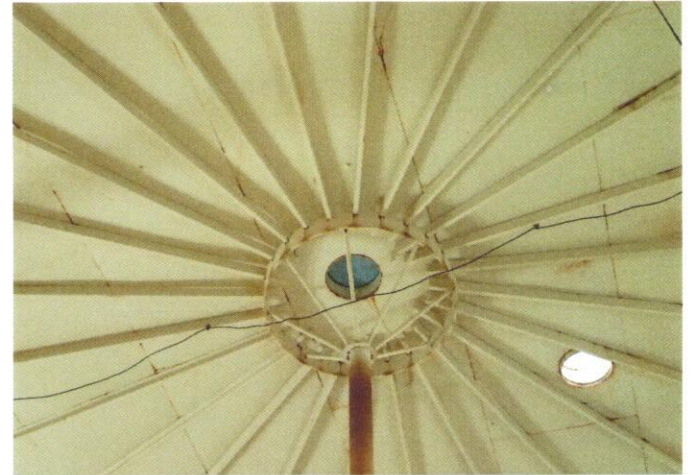
Structurally, this tank was judged to be in acceptable condition with an epoxy protective coating system that is in the initial to advanced stages of deterioration. Photo 19 through 22 indicates the condition of the center support column, roof plates and roof rafters. The areas experiencing surface oxidation are the lap joints, rafters and the area between the rafters and roof plates as seen in photos 23 through 26. Complete coverage of these areas is difficult since they are not completely exposed. A roof to sidewall area is shown in photo 27 with pinhole coating failures and surface rust. This condition was noted in several areas. Typical rafter attachment areas are shown in photos 28 and 29 with pinholes failures and rust stains bleeding. All the attachment areas appear to be in the same condition. Delamination of a roof rafter can also be seen in photo 29. Overall views of the sidewall areas are shown in photos 30 through 32. The dark areas depict staining and sediment deposits on the wall surface; however, coating failures were noted. Photo 33 shows the weld seams with minor pinhole failures. An additional view of coating failures on the sidewall area are shown in photo 34. Overall views of the floor of the tank can be seen in photos 35 and 36

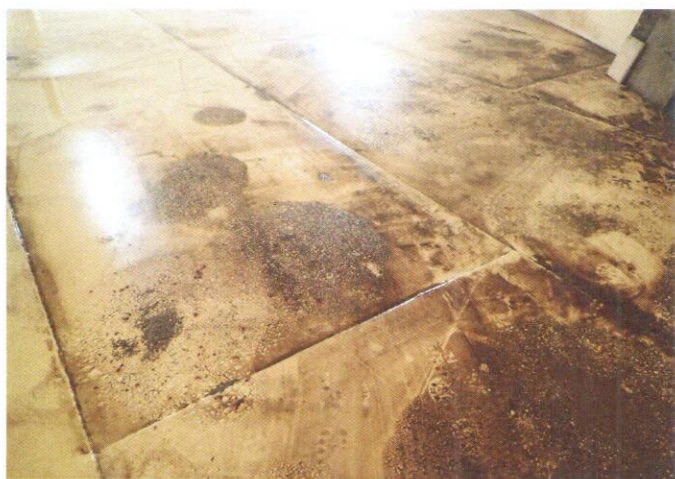
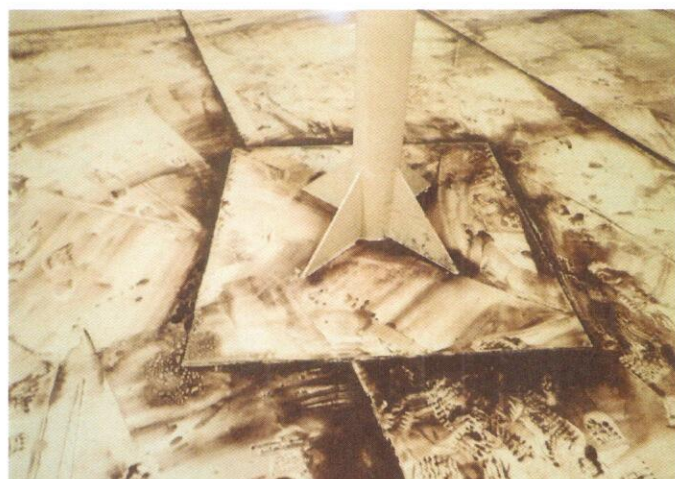
with blister failures noted throughout. Close-up views of the blister coating failures on the floor are shown in photos 37 through 40. Photo 41 and 42 shows the overflow with coating failures and corrosion. The interior ladder and support brackets are shown in photos 43 through 45 with severe corrosion. The interior ladder is structurally unsound and should not be used.
