Wastewater Department Memorandum

DATE: February 20, 2015
FROM: Darryl Pyawasay, Maintenance Supervisor
TO: Jody Hooks, Public Works Manager W/WW
SUBJECT: Submersible Lift Station Pump Repairs- DSWWTP 185 hp, Woodcock LS 15 hp, & State Hwy 3 LS 7.5 hp

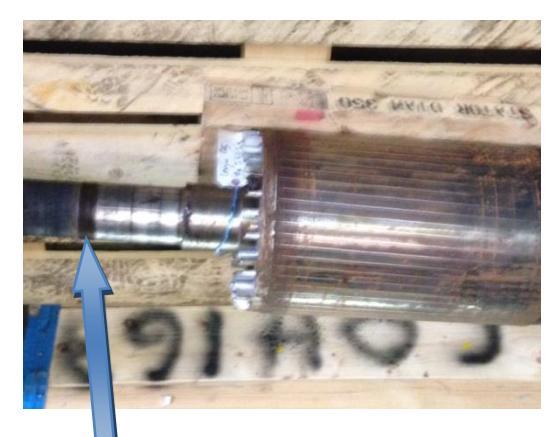
This Image is the rotor shaft, which is part of the pump where the impeller is attached and the mechanical seals and bearings ride on. The wear shown is from worn imbalanced impeller that caused the shaft to wobble, ultimately leading seal and bearing failure. The shaft damage is considered excessive and exceeds allowable tolerances for reconditioning.

- 1. The amount of debris and grit being pumped, causing the failure of the impeller which damaged the impeller resulting in seal and bearing failures which, damaged the rotor.

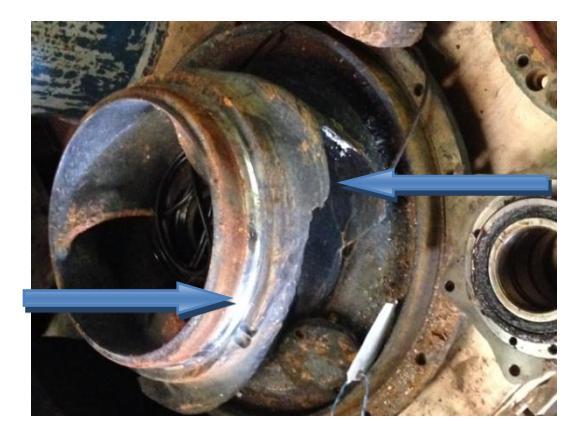
This image is the pump impeller that will be replaced. The damage occurred over time from grit and debris in wet well. Wear is excessive and beyond rebuild/rebalance capabilities.

- 4. We have addressed most of these issues by frequent pump inspections of the impeller and other mechanicals on the pump. We have also increased the frequency of wet well clean out performed to reduce the amount of grit and debris being pumped. We are investigating the benefits and draw backs of raising the wet well level to fully submerge these pumps, to reduce corrosion of the outer casing from hydrogen sulfide gases.

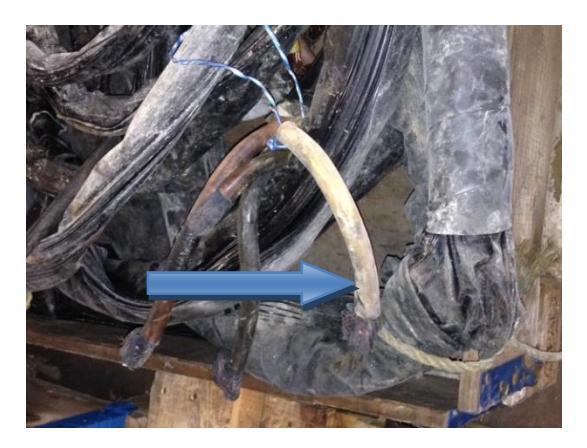
This image is the pump cord. The leads and cord are damaged from the Hydrogen Sulfide gas intrusion in wet well environment.

- 2. Hydrogen Sulfide gases migrating into the electrical boxes damaging the cord connections.
- 3. Corrosion of the outer casing to the where the cords seal into the pumps causing moisture to seep into the upper pump electrical connections.

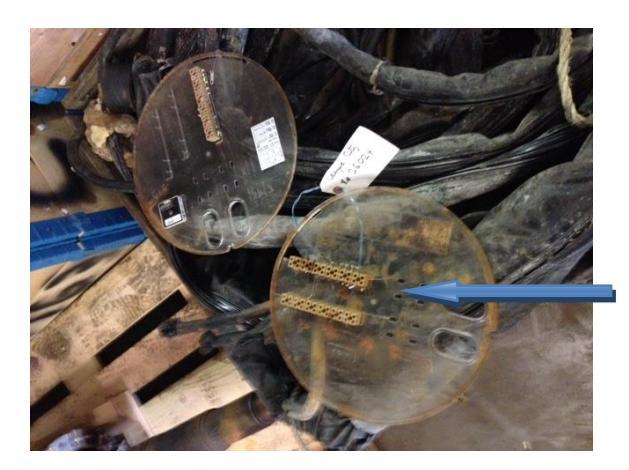
This image is the internal wire connections to the pump. Shows the moisture incurred from the damage of the pump cord. The Mini-Cas (Electronic Protection) protected this pump from stator damage.

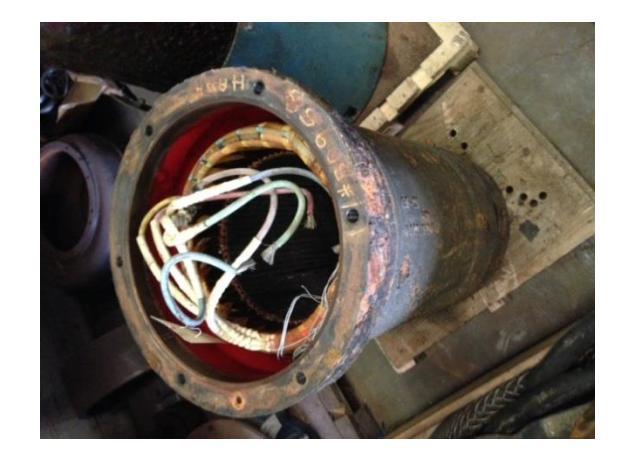
This image is the undamaged stator, leads and the windings were in very good condition.

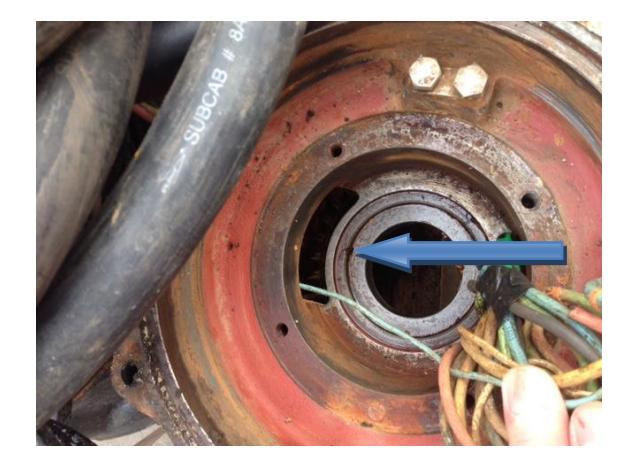
This image is the bearing housing shows wear from water wash out due to water migrating into the pump from cord seal failure.

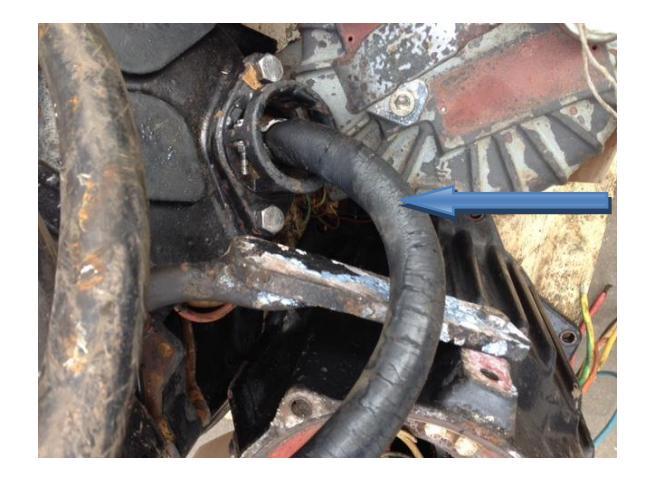
This image is the cord and cord seal notice the corrosion of the cord from hydrogen sulfide gases creating a cord seal failure which allows moisture into the top bearing and electrical housing pictured above.

2: Cord damage was caused by hydrogen sulfide gases in the wet well.

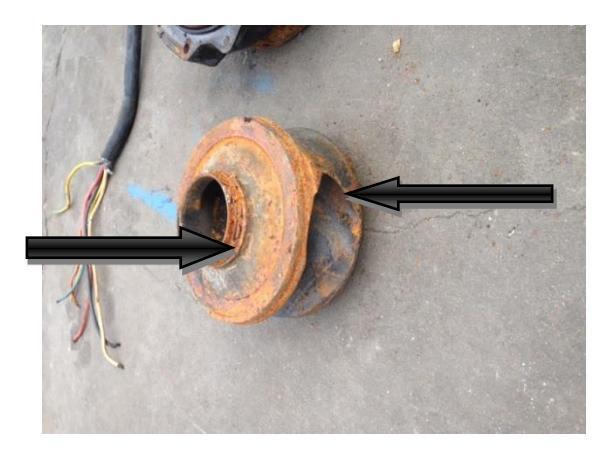
This image is the pump impeller that will be replaced. The damage occurred over time from grit and debris in wet well. Wear is excessive and beyond rebuild/rebalance capabilities.

1. The amount of debris and grit being pumped, causing the failure of the impeller which damaged the impeller resulting in seal and bearing failures which in turn damaged the rotor and reduced the insulation value of the stator.

We have addressed these issues by frequent pump inspections of the impeller and other mechanicals on the pump to include the electrical cords. We have also increased the frequency of wet well clean out performed to reduce the amount of grit and debris being pumped.

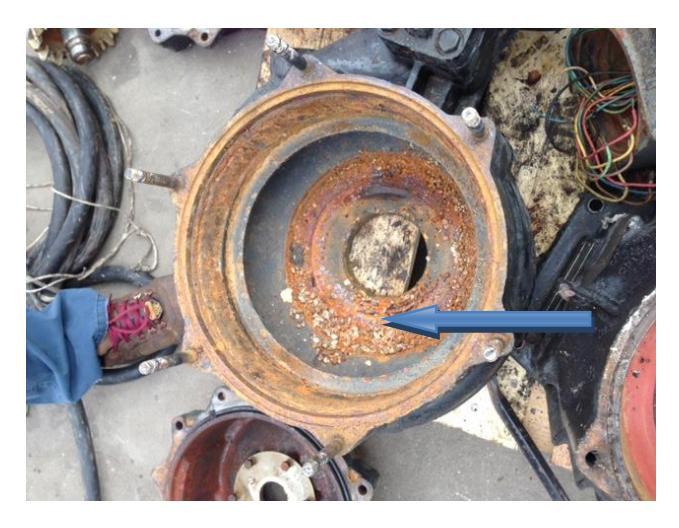
This image is the pump volute, where the pump impeller sets; this shows the amount of grit inside the pump causing damage to the wear ring area of the impeller. Volute will be reconditioned for proper fit.

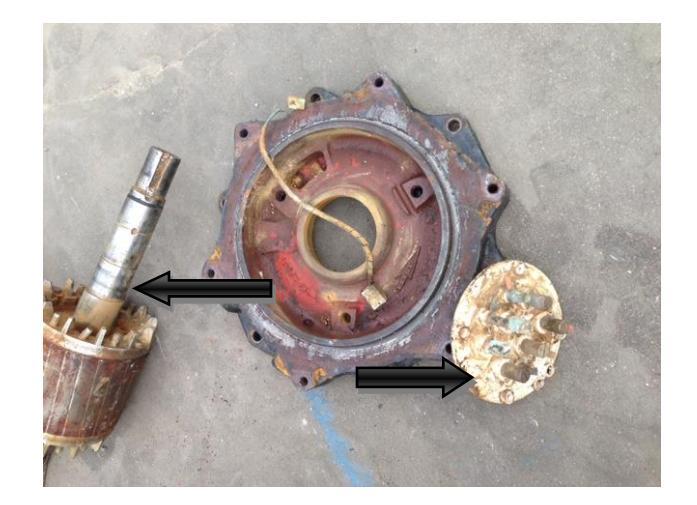
This image is the internal electrical connections showing damage from moisture due to cord seal failure. To the left is the rotor shaft, which is part of the pump where the impeller is attached and the mechanical seals and bearings ride on. The wear shown is from worn imbalanced impeller that caused the shaft to wobble, ultimately leading seal and bearing failure. The shaft damage is considered within tolerances for reconditioning.

The rotor and stator are only in need of reconditioning because the Mini-Cas pump protection had stopped the motor before significant damage had occurred. The stator was Megged and found to be out of Specs, which were less than 500 hundred Megohms which is the industry standard. Megging the motor is checking the insulation value of the windings on a stator with a Megohm meter. The rotor shaft damage was to the point where reconditioning could be done without the need of replacement.

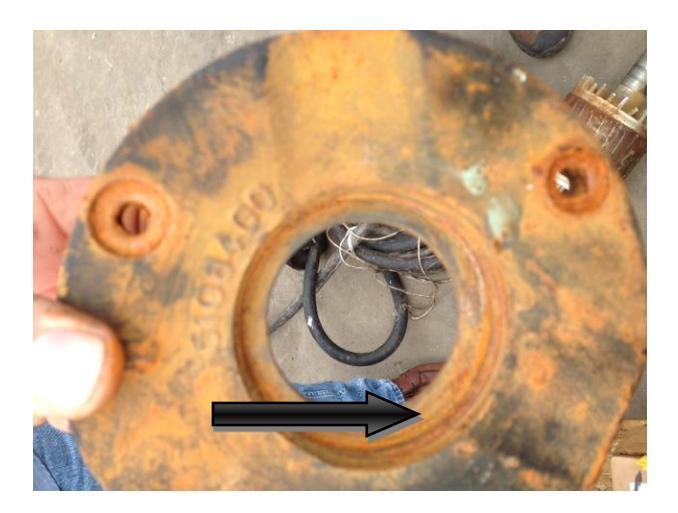
This image is the upper bearing flange where the upper bearing sets in, it shows wash out from water in the pump which will need to be replaced for proper fitment of the new bearing.

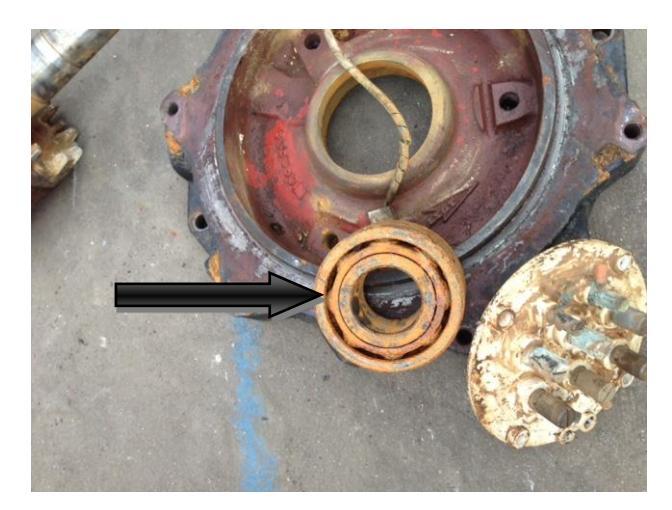
This image is one of the bearings that were washed out from water in the pump.

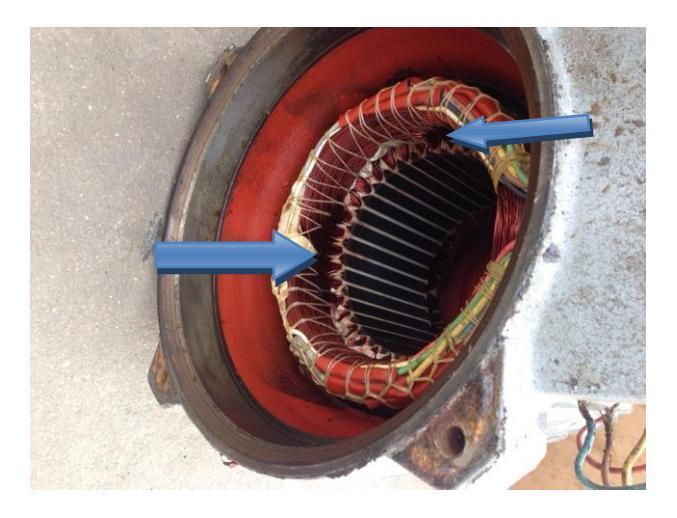
This image is the stator, which the rotor rides in to drive the pump, picture shows the burnt out windings of the stator from water in the pump. The stator will be replaced because it is not cost effective to rewind on this size of motor.

1: The amount of debris and grit being pumped has caused the failure of the impeller resulting in seal and bearing failures which in turn caused moisture to get in the stator and bearings.

2: The Mini-Cas stopped the pump but was reset causing the short on the motor windings.

We have addressed these issues by frequent pump inspections of the impeller and other mechanicals on the pump. We have also increased the frequency of wet well clean out to reduce the amount of grit and debris being pumped. We have also directed our Utility technicians to call maintenance before resetting to ensure protection of the motor windings. The Maintenance technicians are instructed to test the pump protection device to ensure proper operation before restarting the pump; they were also retrained and talked to about ensuring proper pump installation before putting back into service.

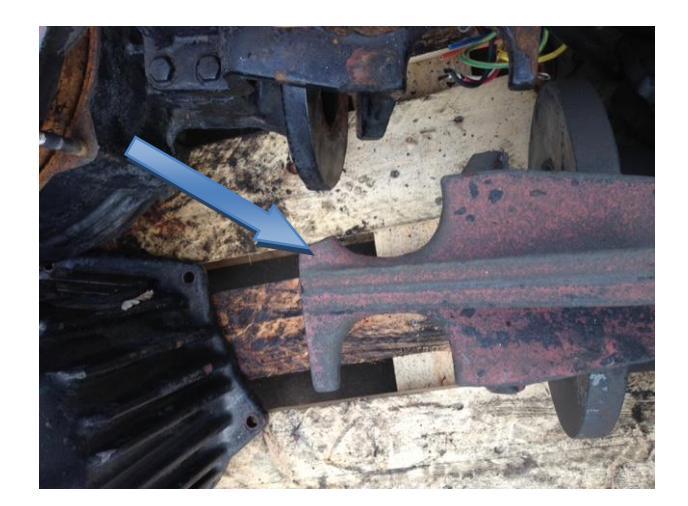
This image shows busted guide rail slide that assists in the proper alignment of the pump to sit on the base 90 pipe. The broken tab is from improper installation after being serviced.

3: The busted guide rail slides on the volute were from improper installation.

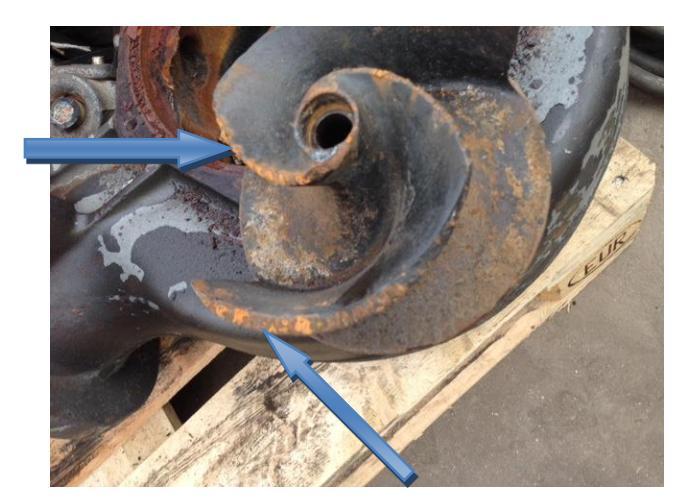
This image is the pump impeller. The damage occurred over time from grit and debris in wet well. Wear is not excessive and can be reconditioned and rebalanced.

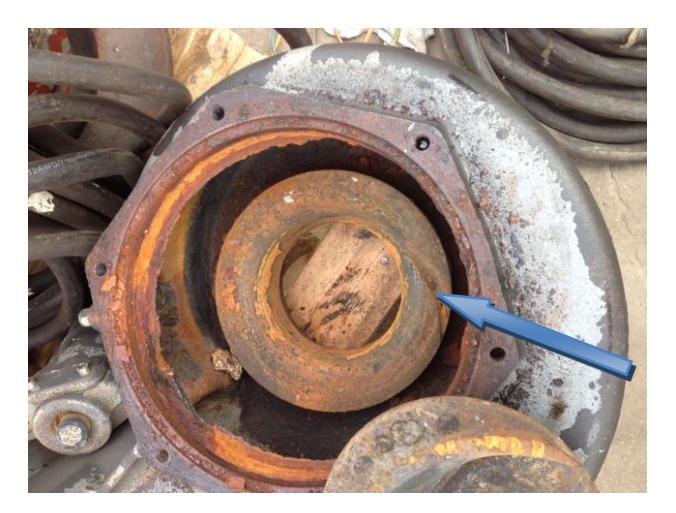
This image is the pump volute, where the pump impeller sets; this shows the damage from grit inside the pump. Volute cannot be reconditioned for proper fit.
