## Slope Paving Report

Bay Area Boulevard at Alderwood

## Slope Paving Failure at Sound Wall

June 26, 2014

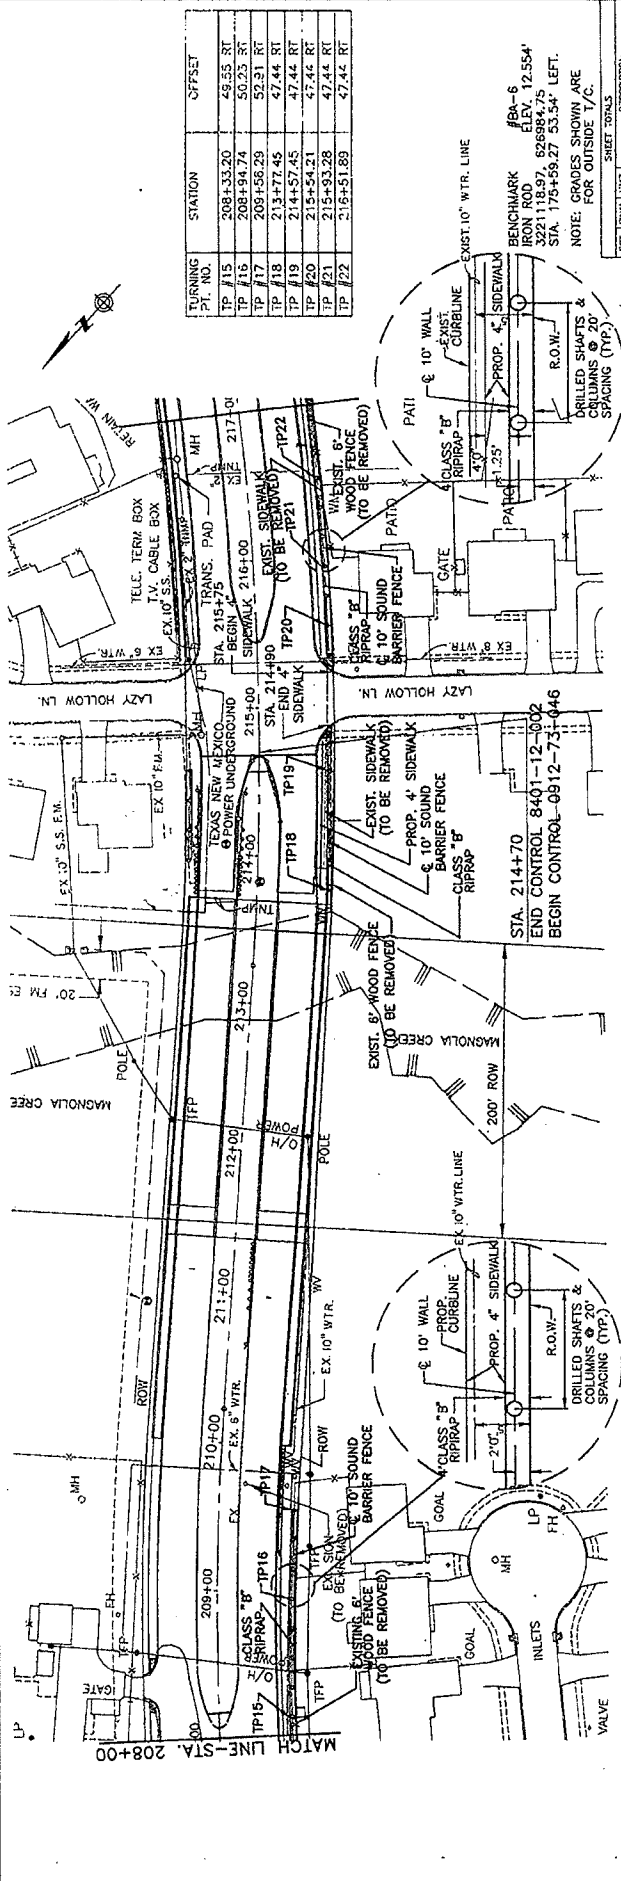
## EXHIBIT "B" PHASE 2 SLOPE PAVING REPAIR OPTIONS 1-3

The second factor to address is the slope paving failure and leveling pad settlement. The slope paving has pulled away from the drilled shaft at every column due to settlement. Options that would allow the repair of the areas of concrete failure are explored below.

Saw cut and remove the slope paving a minimum of two feet around each of the drilled shafts with a full depth saw cut, install flowable fill or properly compacted select fill, where voids are found, and install a board expansion joint to separate the new and old slope paving. Where the damaged area extends beyond two feet, the saw cut should extend to the limit of the damaged area. Remove the concrete immediately around the column and install new concrete, or similar surface material. The expansion joint will allow the concrete around the column to move separately from the other slope paving and should minimize future cracking. In addition to the areas around the columns, saw-cut and replace the slope paving where failure has occurred in other select areas. The sound wall leveling pad may be able to be raised by
