RE: EVALUATION OF CITY OF LEAGUE CITY
WELDED GROUND STORAGE TANK NO. 1
AT THE CALDER WATER PLANT

**EVALUATION OF
CITY OF LEAGUE CITY
WELDED GROUND STORAGE TANK NO. 1
AT THE
CALEDON WATER PLANT**

REPORT OF: Welded Ground Storage Tank No. 1

DATE INSPECTION PERFORMED: March 27, 2017

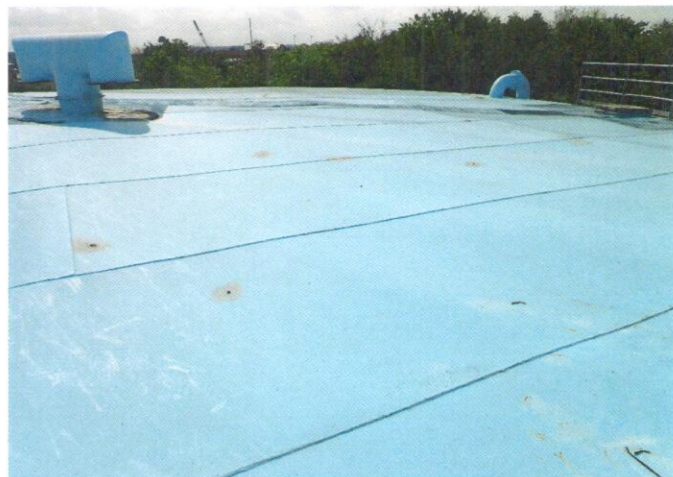
The exterior protective coating system is in the initial to advanced stages of deterioration. Photo 1 and 2 provides overall views of the exterior coating system. The protective coating has chalked, faded and is no longer self-cleaning. Impact areas on the tank exterior are shown in photo 3 with surface rust. Overall views of the roof are shown in photos 4 and 5 with coating failures noted throughout. Close-up views of the coating failures and surface rust are shown in photos 6 through 9. Photo 6 also shows deterioration of the non-skid surface on the roof of the tank. Photo 9 shows an area of previously ponding water on the roof. This condition will lead to premature failure of the protective costing system. The surface water piping and connections are shown in photos

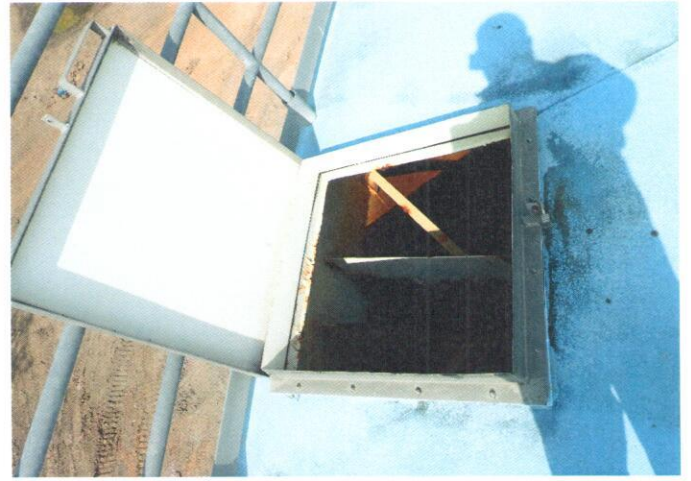
10 and 11 with surface rust at the roof connection area. A maintenance hatch is shown in photo 12 with coating failures and surface rust. The roof vent is shown in photo 13 with surface rust along the leading edges of the collars. The screens continue to provide adequate protection against insects, rodents, vermin and other intrusions into the tank. The roof overflow and access hatches are shown in photos 14 and 15 with coating failures along the interior leading edges. The sidewall access manway and cleanout are shown in photos 16 and 17 in acceptable condition. The overflow flap and drain valve appear to be operating properly, as shown in photo 18.

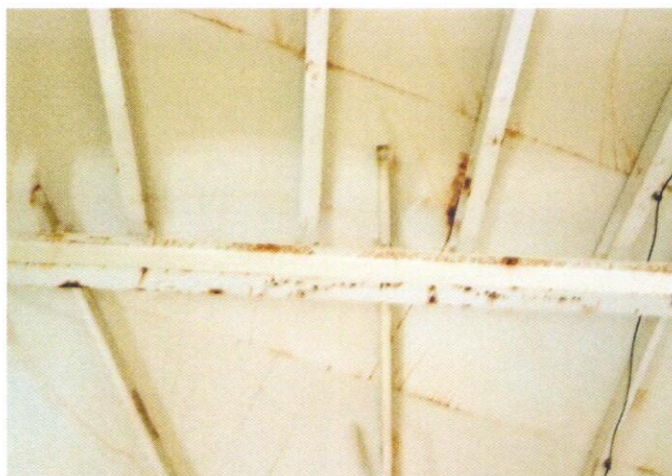
Structurally, this tank was judged to be in acceptable condition with an epoxy protective coating system that is in the initial to advanced stages of deterioration. Photo 19 through 22 indicates the condition of the center support column, roof plates and roof rafters. The areas experiencing surface oxidation are the lap joints, rafters and the area between the rafters and roof plates as seen in photos 23 through 26. Complete coverage of these areas is difficult since they are not completely exposed. A roof to sidewall area is shown in photo 27 with pinhole coating failures and surface rust. This condition was noted in several areas. Typical rafter attachment areas are shown in photos 28 and 29 with pinholes failures and rust stains bleeding. All the attachment areas appear to be in the same condition. Delamination of a roof rafter can also be seen in photo 29. Overall views of the sidewall areas are shown in photos 30 through 32. The dark areas depict staining and sediment deposits on the wall surface; however, coating failures were noted. Photo 33 shows the weld seams with minor pinhole failures. An additional view of coating failures on the sidewall area are shown in photo 34. Overall views of the floor of the tank can be seen in photos 35 and 36
