Development Services
500 W. Walker St.
League City, TX 77573
O: 281.554.1446
F: 281.554.1460
C: 281.554.1446
www.leaguecitytx.gov

Speed Zone Study for Isla Vista Drive Between State Highway 96 and Mar Bella Parkway

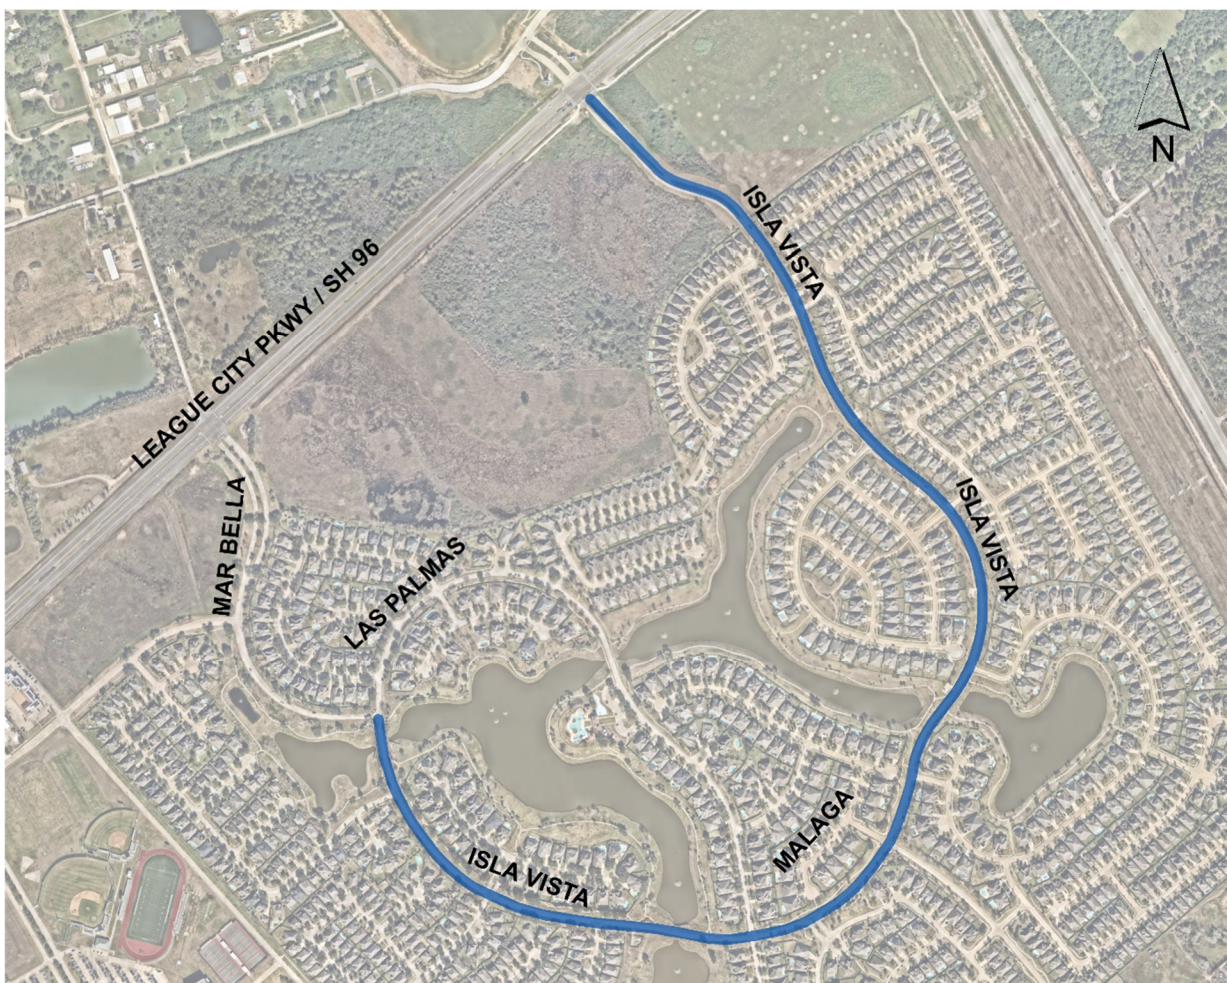
Figure 1 Aerial of Study Corridor

Location: Isla Vista Drive between State Highway 96 and Mar Bella Parkway in League City, Texas (See Exhibit A and Figure 1 for aerial of study corridor).

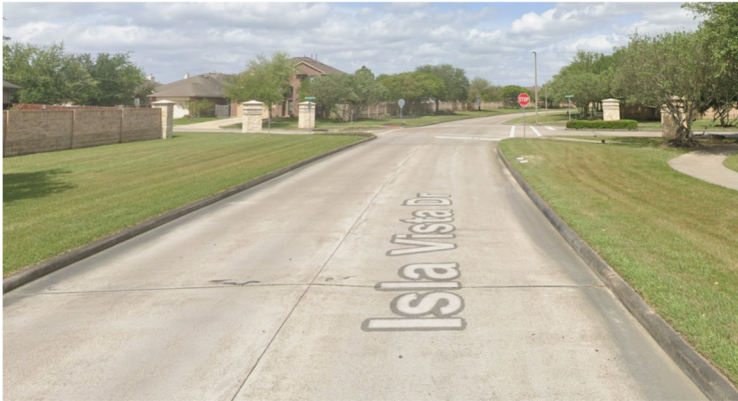
- **Roadway Type Designated in the 2018 City of League City Major Thoroughfare Plan:** Collector
- **Number of Lanes:** Two lane undivided - one lane in each direction

Figure 2 Cross Section of Study Corridor

- **Roadway Type:** Concrete with curb and gutter
- **Segment Length:** 1.56 miles
- **Posted Speed Limit:** 25 mph
- **Traffic Volume:** Average Daily Traffic Volume - 3123
- **Land Use:** Residential
